Manhole Inspection Summary

Manhole # S17AA1002MH

Location Address: **2300 DRUID HILL PARK**

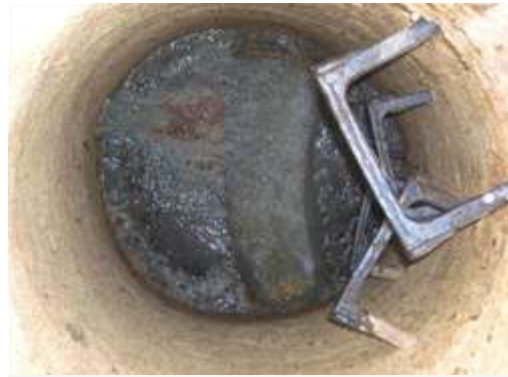
Top View

19 pipe flow is coming into MH without channel and hitting the bench

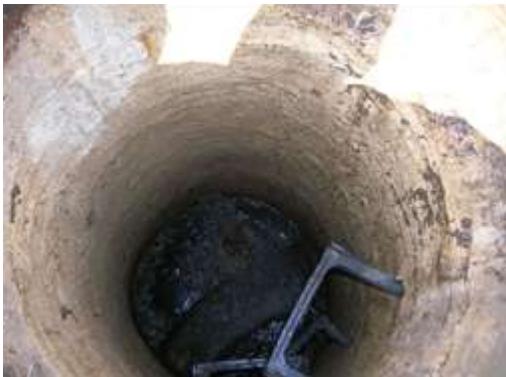
Defect

Frame leaks. Adjustment infiltration - other side.

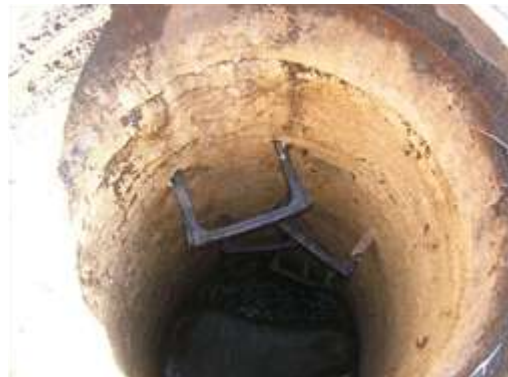
Defect

Frame leaks. Adjustment infiltration.

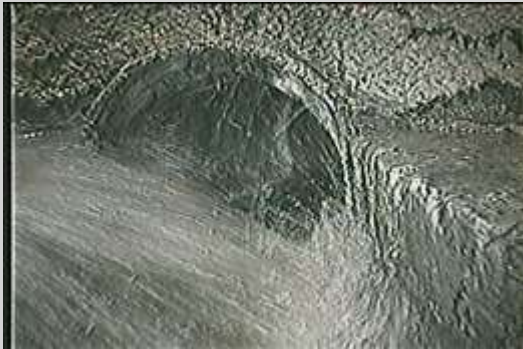
15 in. Circular Gravity Sewer Pipe Out @ 12 O'Clock

Pipe Material: **Unknown** ☒ Pipe Lined

Invert Depth: **10.89** (ft.) Flow Characteristics: **Fast**

Infiltration: **None** Pipe Seal Cond: **Unknown**

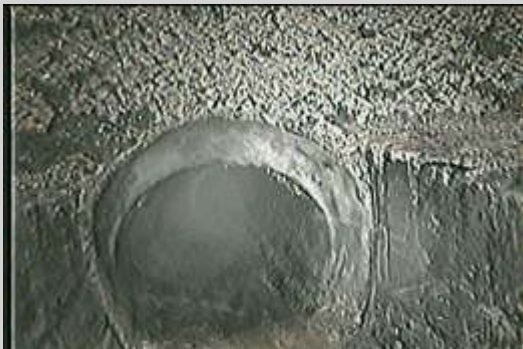
12 in. Circular Gravity Sewer Pipe In @ 5 O'Clock

Pipe Material: **Unknown** ☒ Pipe Lined

Invert Depth: **10.83** (ft.) Flow Characteristics: **Fast**

Infiltration: **None** Pipe Seal Cond: **Unknown**

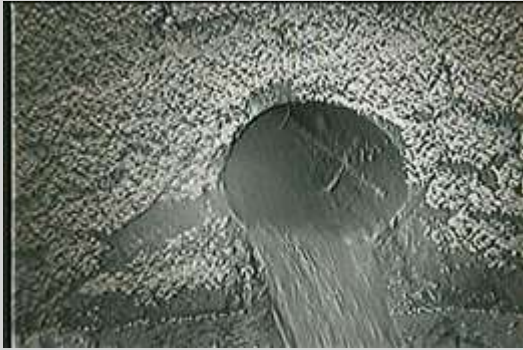
8 in. Circular Gravity Sewer

Pipe Material: **Clay**

Invert Depth: **9.61** (ft.) Flow Characteristics: **Turbulent**

Infiltration: **None**
